Neutral Citation Number: [2022] EWHC 1190 (Admlty)

**IN THE HIGH COURT OF JUSTICE**  
**QUEEN'S BENCH DIVISION**  
**ADMIRALTY COURT**

(1) WILFORCE LLC  
(2) AWILCO LNG AS  
(The Owners and Demise Charterers of the  
LNG Tanker "WILFORCE")

(1) RATU SHIPPING CO.SA  
(2) SEA QUEEN SHIPPING CORPORATION  
(The Owners and Demise Charterers of the  
MV "WESTERN MOSCOW")

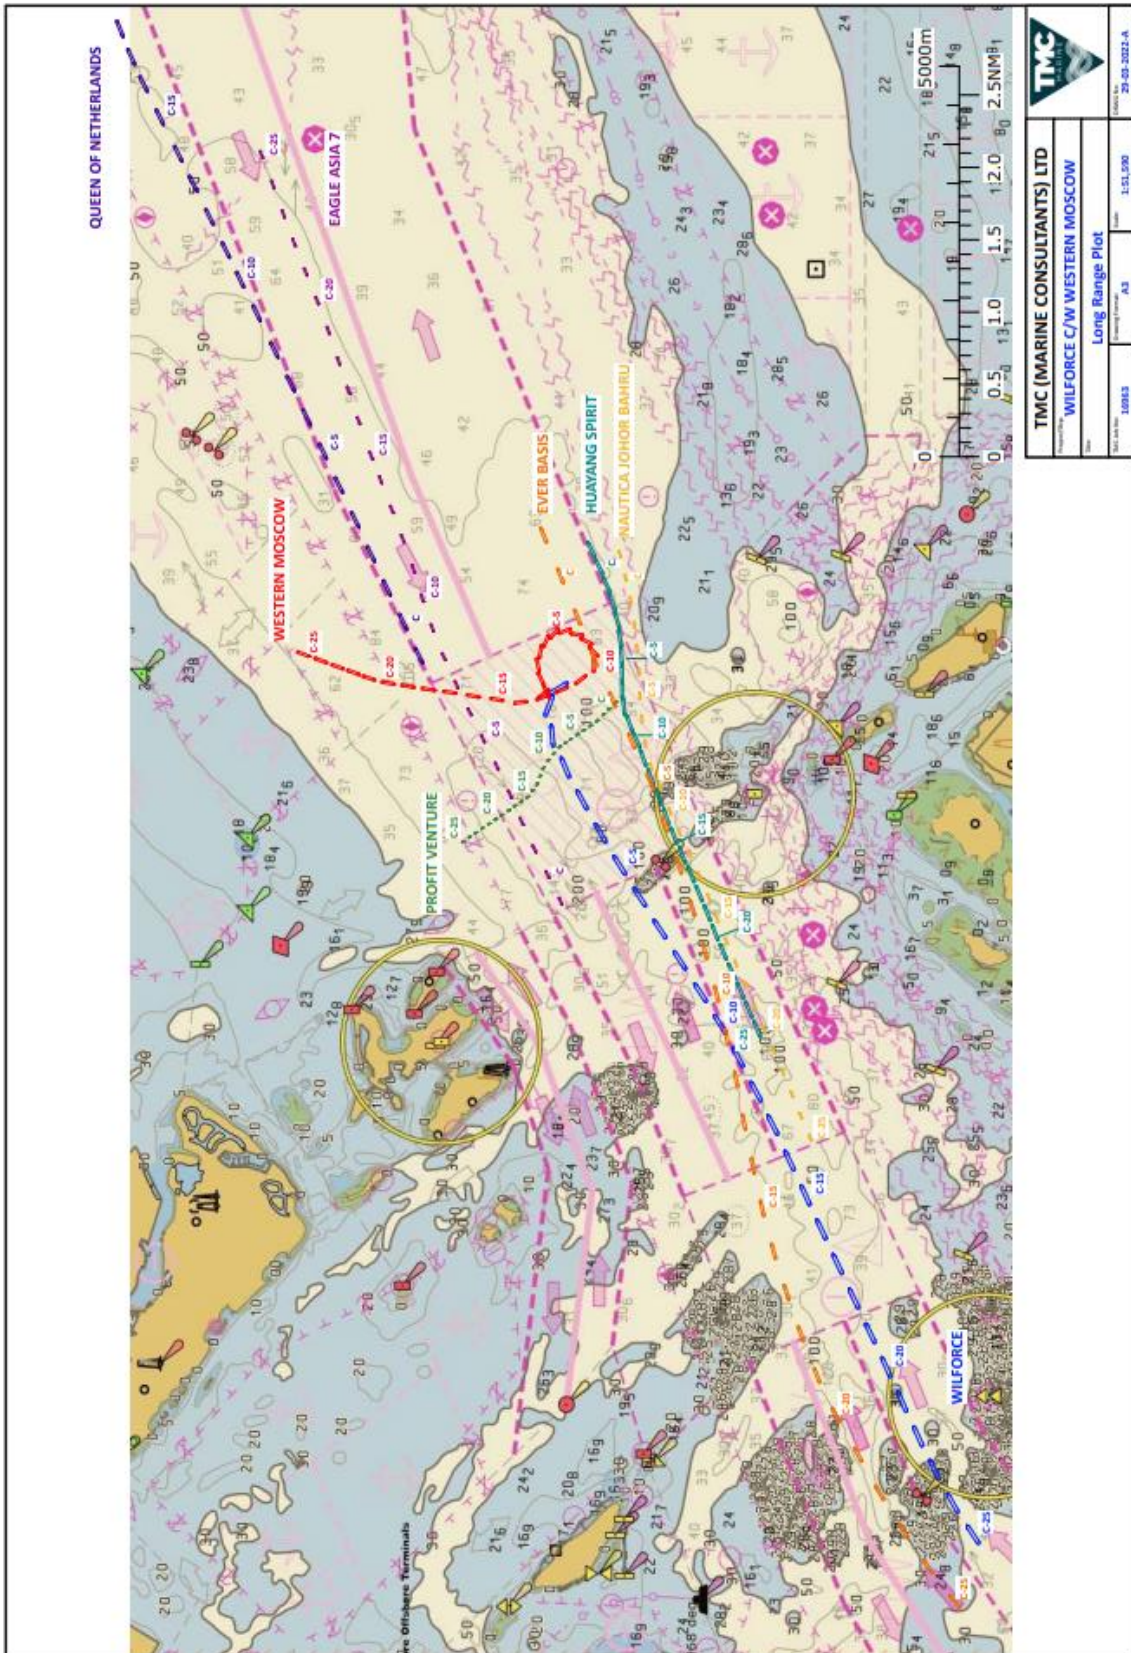
### TMC – Long Range Plot

17. The available electronic data enables the navigation of the vessels to be described from C-25. I have attached to this judgment a plot entitled “Long Range Plot” which illustrates the vessels’ navigation. The agreed reconstruction shows that, as WILFORCE was proceeding eastwards in the eastbound traffic lane at about C-13, WESTERN MOSCOW crossed ahead of her from port to starboard, at a distance of about 3.5 miles, as she crossed the Precautionary Area in a south-going direction. WESTERN MOSCOW continued southwards until about C-10 when she turned to port in an easterly direction. At this time there was no risk of a collision between WILFORCE and WESTERN MOSCOW. It follows that the events from C-25 until C-10 are part of the history leading up to the collision but not effective causes of it. They may provide context and illustrate alleged deficiencies in the standard of the vessels’ navigation but what really matters is the navigation of the vessels immediately before a risk of collision arose and the actions which each vessel took or did not take to avoid collision. I have well in mind Lord Sumner’s observation in *The Peter Benoit* (1915) 13 Asp. MLC 203 at p.208 about matters which are only “introductory” or “antecedents” even though “they preceded the collision by but a short time”.

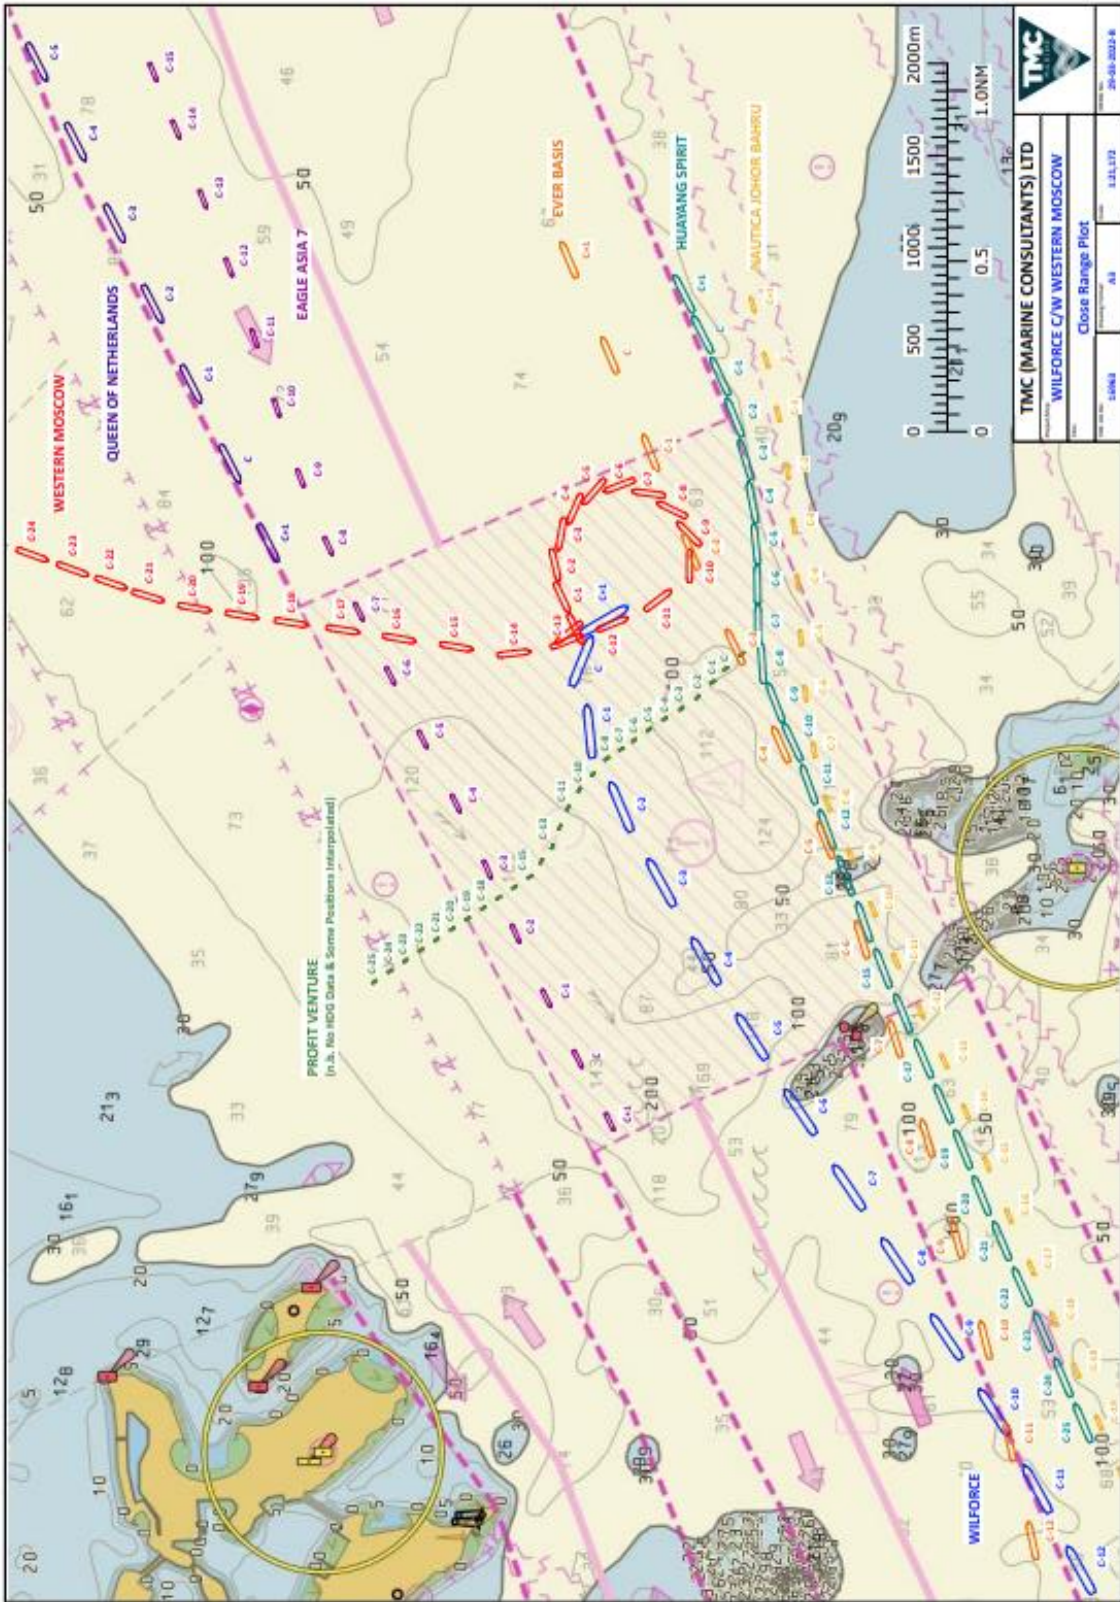
**TMC – Short Range Plot**

18. I shall therefore summarise the vessels’ navigation from about C-10. I attach to this judgment a copy of the agreed reconstruction which shows the navigation of WILFORCE from just before C-10 and is entitled “Close Range Plot”.
